Manhole Inspection Summary

Manhole # S41SS_004MH

Insp Date: **2/20/07 9:48 AM**

Location Address: **2565 CECIL AVE**

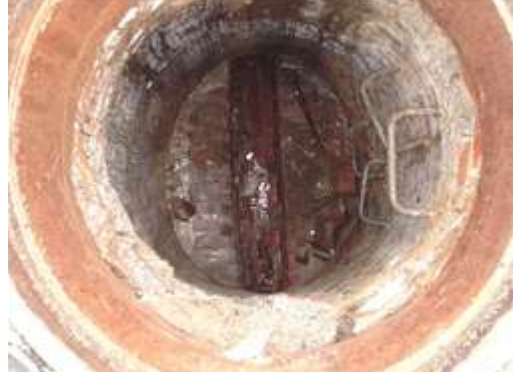
Top View

Barrel infiltration. Evidence of surcharge - Bench debris.

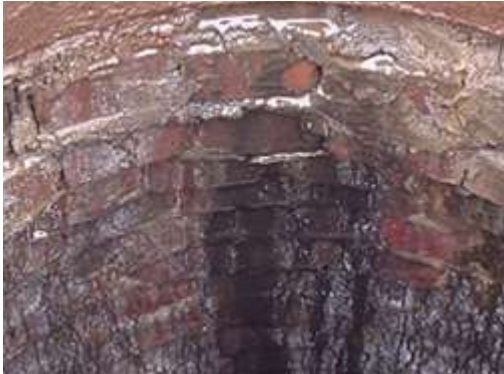
Defect

Frame leaks. Adjustment deterioration and infiltration. Corbel infiltration.

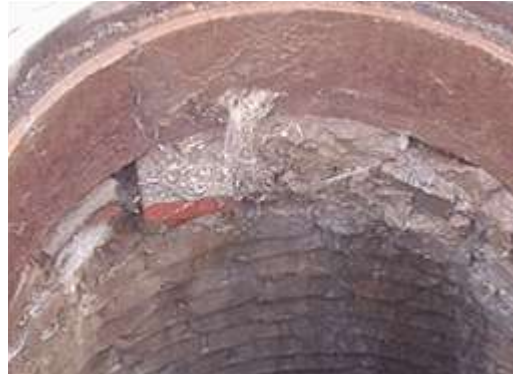
Defect

Frame leaks. Adjustment deterioration, loose brick and infiltration.

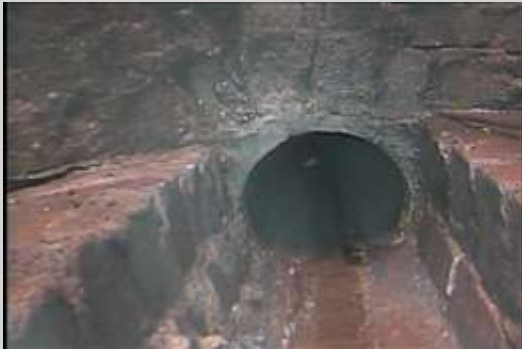
8 in. Circular Gravity Sewer Pipe Out @ 12 O'Clock

Invert Depth: **8.81** (ft.) Flow Characteristics: **Slow**

Infiltration: **None** Pipe Seal Cond: **Unknown**

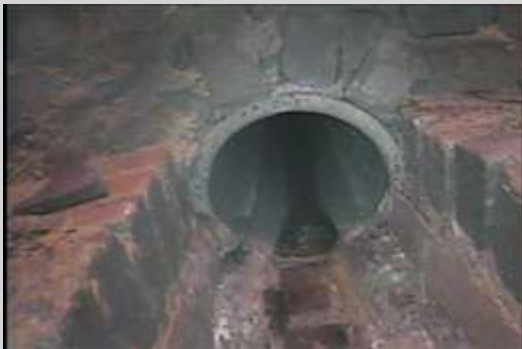
8 in. Circular Gravity Sewer Pipe In @ 6 O'Clock

Invert Depth: **8.39** (ft.) Flow Characteristics: **Slow**

Infiltration: **None** Pipe Seal Cond: **Unknown**
